Flood Control Project Maintenance**2013 Structure Summary Report****Overall Unit and Item Ratings****DWR Sutter Maintenance Yard****Butte Slough Drainage Structure**

Flood Control Project Maintenance
2013 Structure Summary Report
Overall Unit and Item Ratings

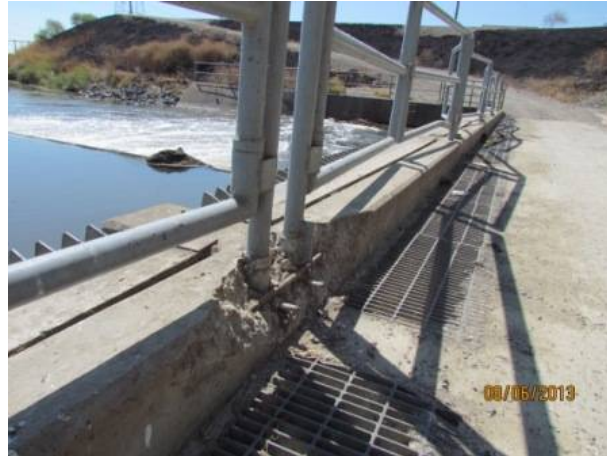
Levee Mile Report Line	3
Start Levee Mile	0.00
End Levee Mile	0.00
Location	
Category	Pump Stations
Item	Plant Building
View of the exposed rebar. LMA noted the deficiency and will repair by next inspection.	
mkhashch_t_20130815_120.JPG

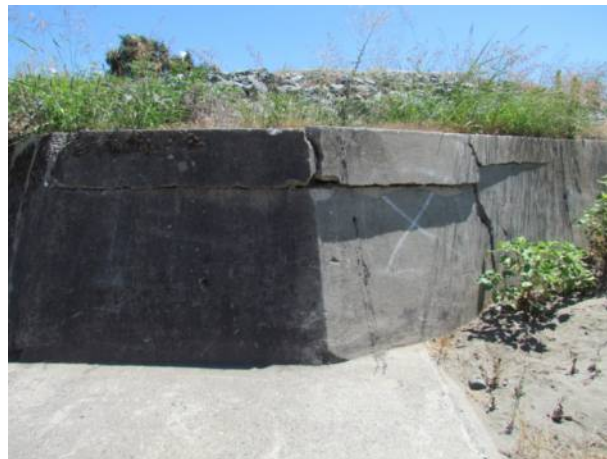
Levee Mile Report Line	1
Start Levee Mile	0.00
End Levee Mile	0.00
Location	
Category	Structures
Item	Photo Documentation
Concrete cracking along the south wing wall.	
mhoffman_t_20130807_046.JPG

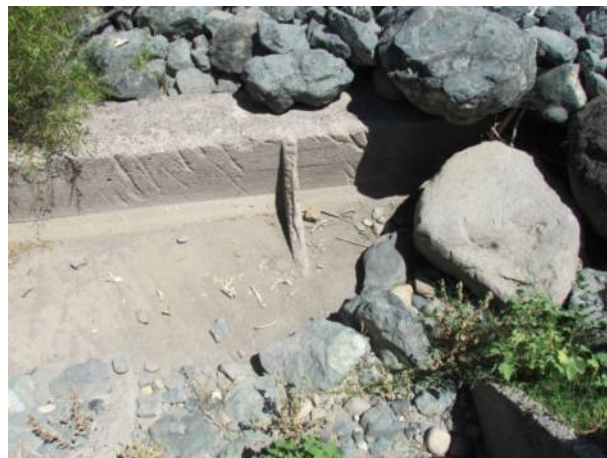
Levee Mile Report Line	1
Start Levee Mile	0.00
End Levee Mile	0.00
Location	
Category	Structures
Item	Photo Documentation
Exposed rebar within the structure.	
mhoffman_t_20130807_047.JPG

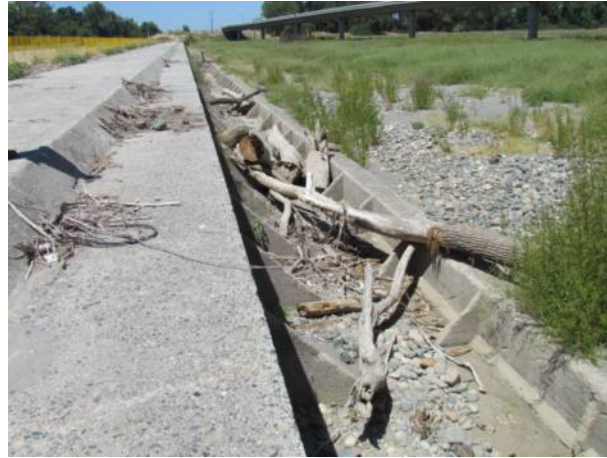
Levee Mile Report Line	1
Start Levee Mile	0.00
End Levee Mile	0.00
Location	
Category	Structures
Item	Photo Documentation
Minor debris still present within structure from prior event.	
mhoffman_t_20130807_048.JPG

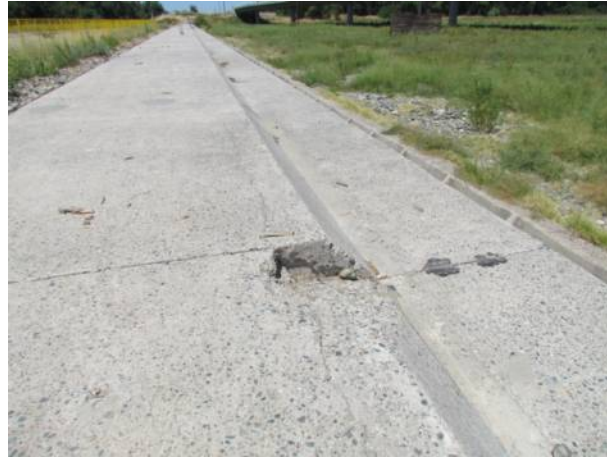
Levee Mile Report Line	1
Start Levee Mile	0.00
End Levee Mile	0.00
Location	
Category	Structures
Item	Photo Documentation
Minor concrete spalling present.	
mhoffman_t_20130807_051.JPG

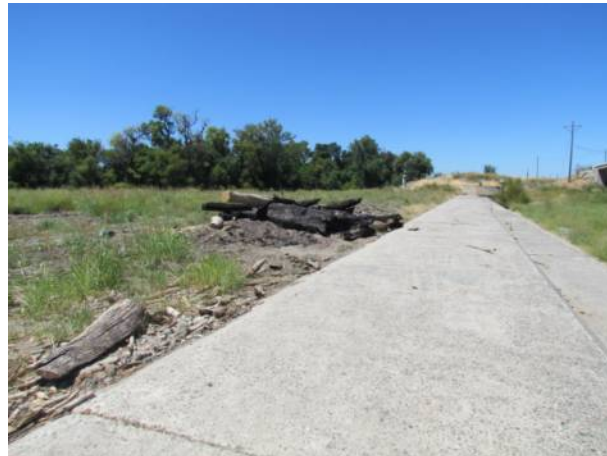
Levee Mile Report Line	1
Start Levee Mile	0.00
End Levee Mile	0.00
Location	
Category	Structures
Item	Photo Documentation
Minor debris still present from previous event.	
mhoffman_t_20130807_052.JPG

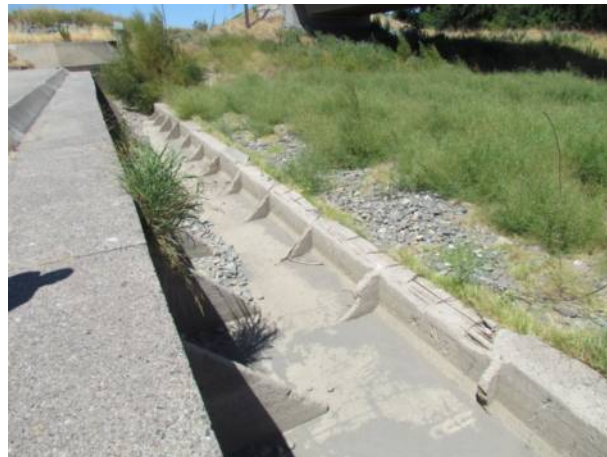
Levee Mile Report Line	1
Start Levee Mile	0.00
End Levee Mile	0.00
Location	
Category	Structures
Item	Photo Documentation
Exposed rebar with lengths in excess of 6 feet. Should be cut off flush with concrete surface.	
mhoffman_t_20130807_053.JPG
